Manhole Inspection Summary

Manhole # S39Q__015MH

Location Address: **511 harborview dr** Cross Street: **harbor island walk**

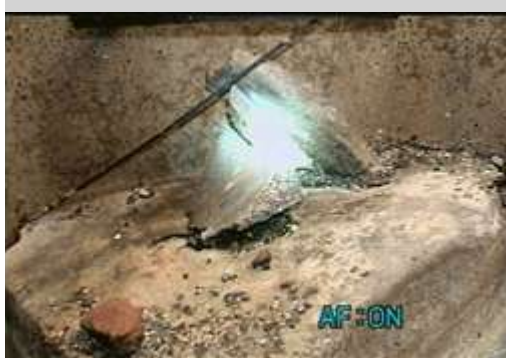
Misc

bench debris

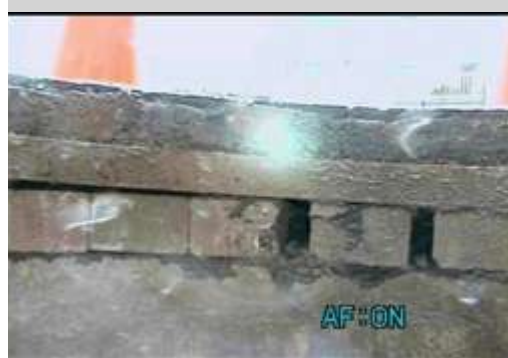
Defect 2

Condition: ☐ Sound ☒ **Cracked** ☐ Root Intrusion ☒ **Loose Brick** ☐ Deteriorated

cracked, loose bricks

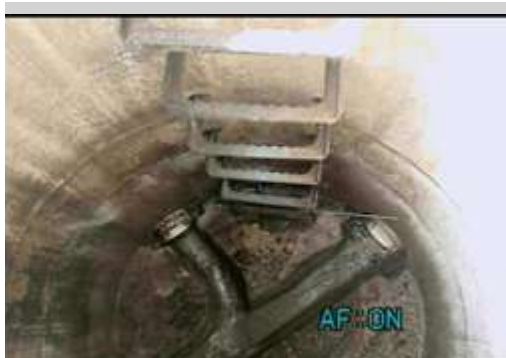
Defect 1

Steps Count: **6** Missing: **0** ☒ **Corroded**

steps

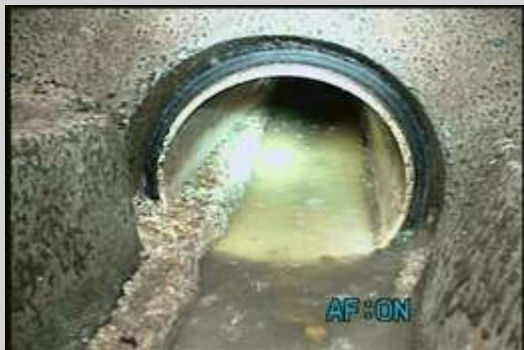
12 O'Clock Outflow

8 in. Circular Gravity Sewer
Pipe Out @ 12 O'Clock

Invert Depth: **7.66** (ft.) Flow Characteristics: **Fast**

Infiltration: **None** Pipe Seal Cond: **Unknown**

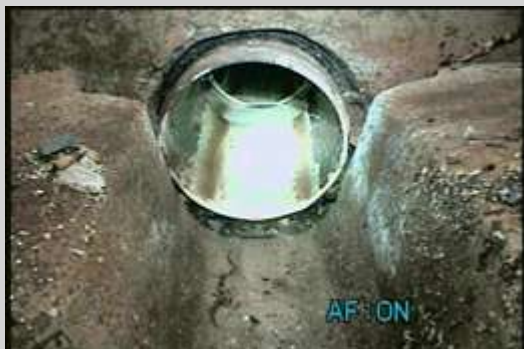
3 O'Clock Inflow

8 in. Circular Gravity Sewer
Pipe In @ 3 O'Clock

Invert Depth: **7.10** (ft.) Flow Characteristics: **Fast**

Infiltration: **None** Pipe Seal Cond: **Unknown**

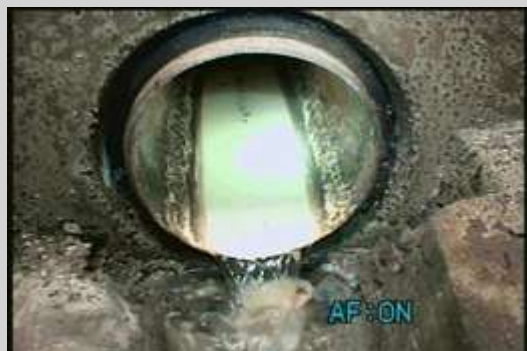
6 O'Clock Inflow

8 in. Circular Gravity Sewer
Pipe In @ 6 O'Clock

Invert Depth: **7.10** (ft.) Flow Characteristics: **Fast**

Infiltration: **None** Pipe Seal Cond: **Unknown**
